Admissions Building
Arkansas State Hospital (ASH)

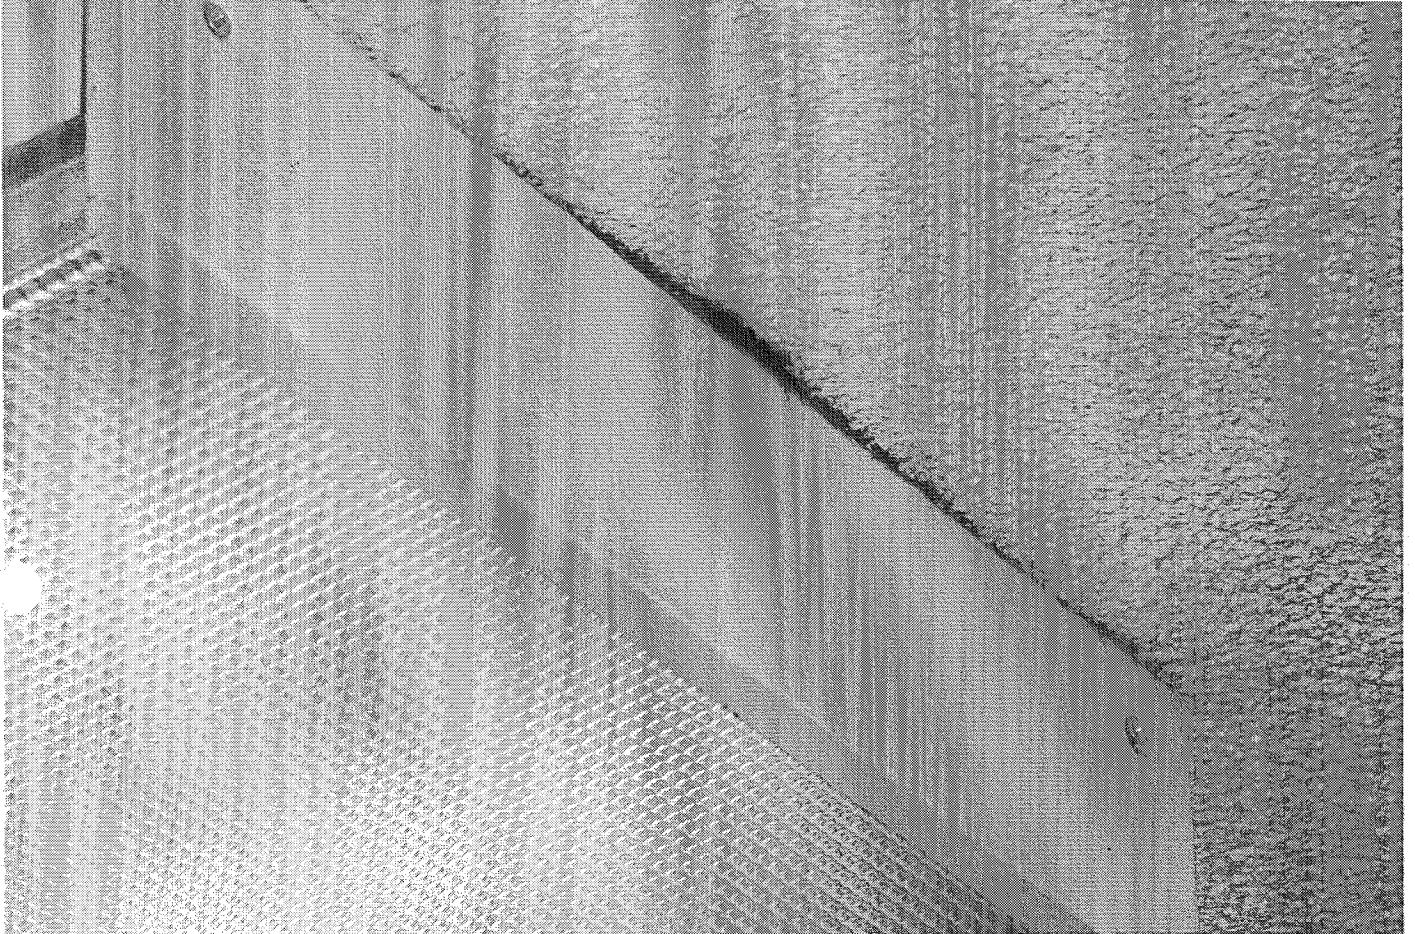
113. Office off east hall - View of damaged acoustical plaster at fluorescent light fixture

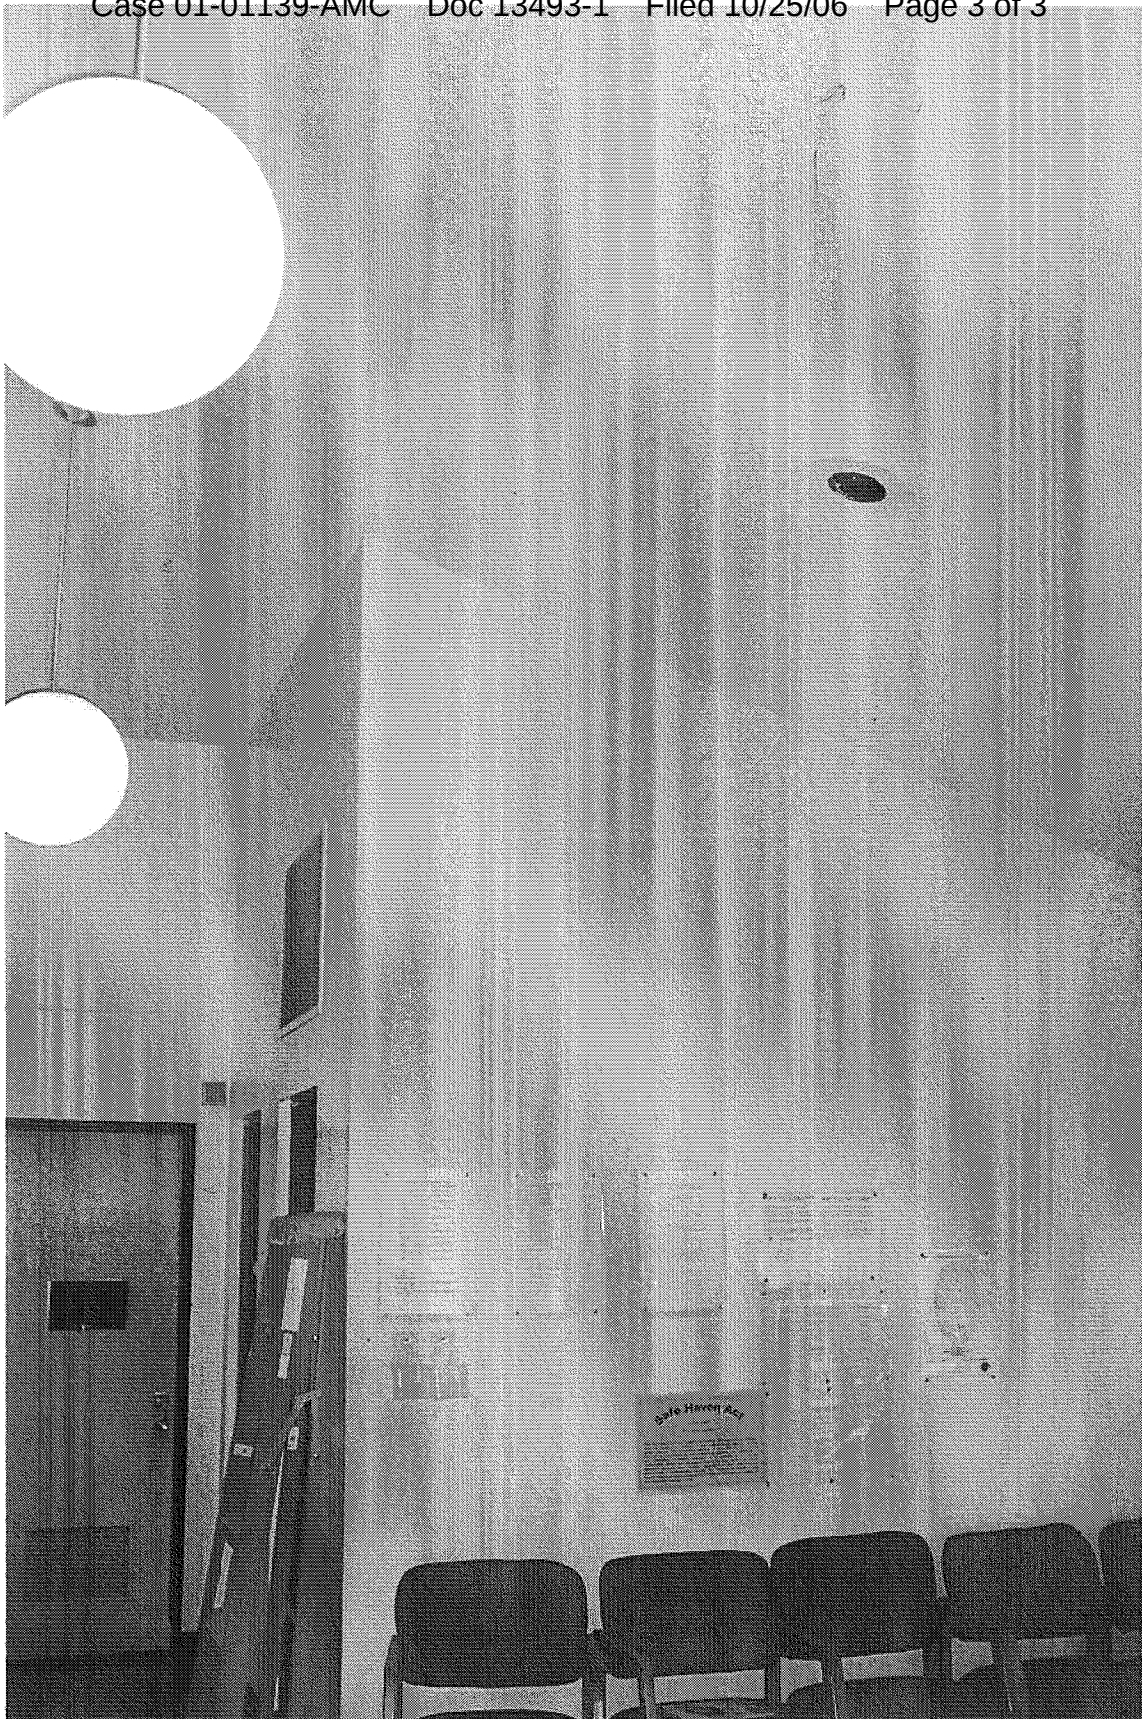
114. Medical Records Area - General view of acoustical plaster ceiling
